Under-Slab Water Pipe Break: To Repair or Repipe?

From: Larry Riggs
Subject: Under-Slab Water Pipe Break: Should I Repair or Repipe?
Date: February 1, 2013

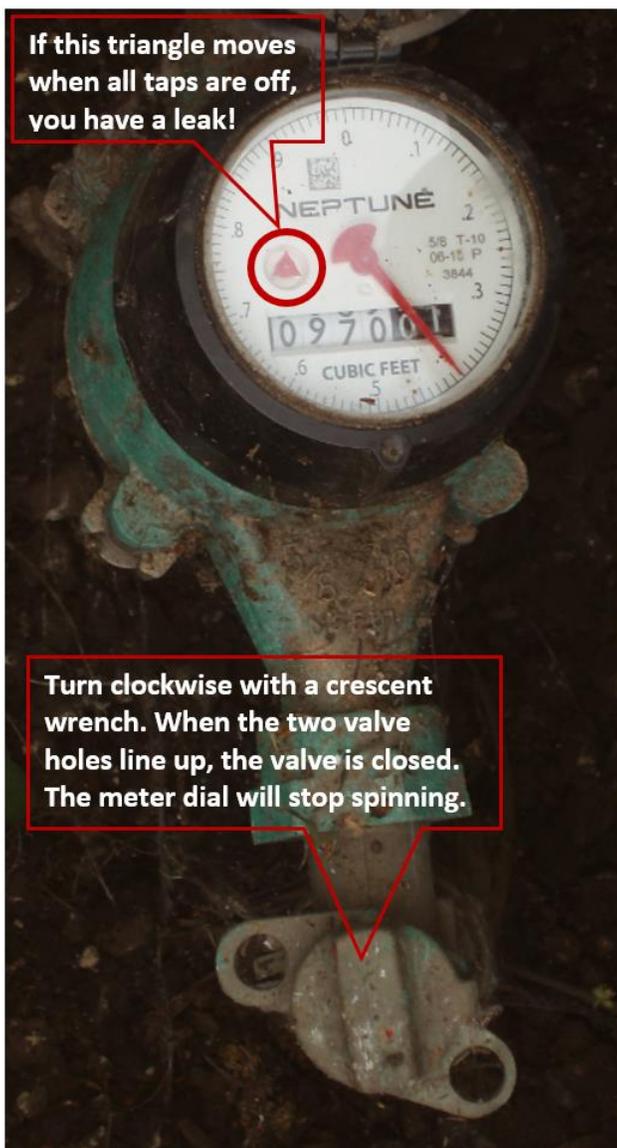
Curbside Water Meter

- With all water turned off in the house, the water meter at the curb showed water flowing through it. The triangle was rotating once every 4 seconds.
- In the downstairs bathroom, one area of the floor was very warm to the touch and other parts of the floor were not.
- When I turned off the hot water output valve at the top of the water heater, the flow through the water meter stopped—the triangle stopped moving. (Note: Code only requires a shutoff valve on the input side of the water heater; mine had valves on both the input and output side.)

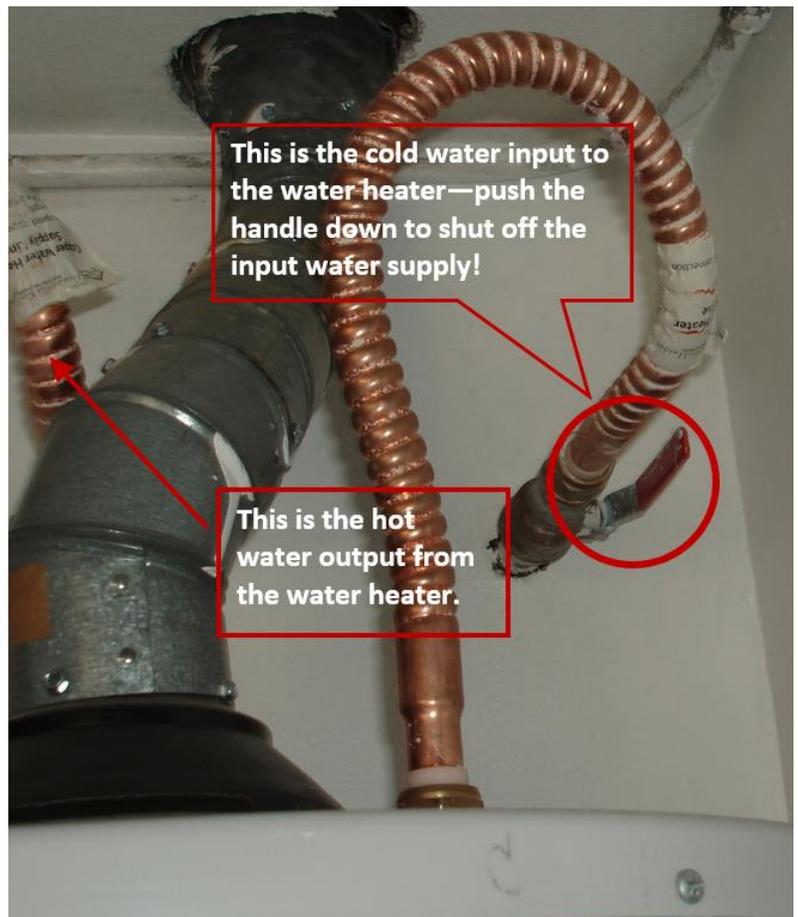
Hot Water Heater in Garage

A break had occurred in that hot water pipe as it passed under the downstairs bathroom.

By shutting off the valve on the water heater's output side, we stopped the flow of water through the leaking hot water pipe, stopped the leak, yet retained the use of cold water. We considered it a remote likelihood that a cold water pipe might break as well. We didn't need to rush to seek a solution, but in the meantime we would have only cold water in the house. We operated without hot water for three weeks, using work or gym or neighbors' showers.

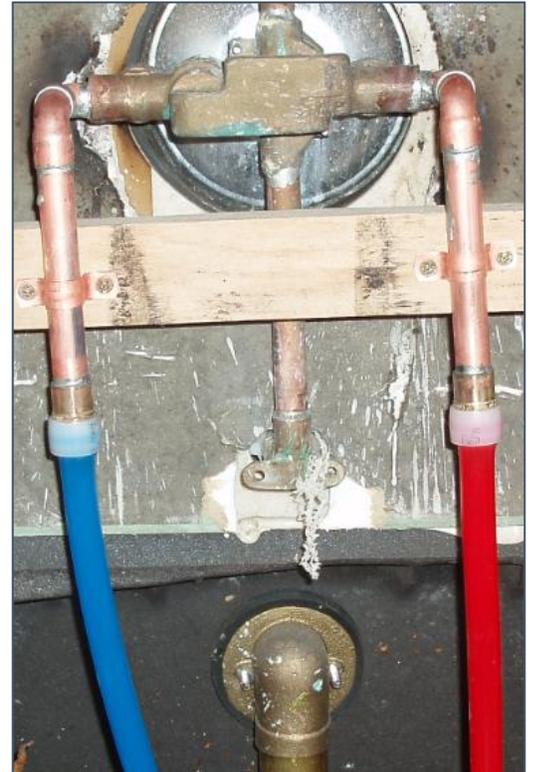
**PEX to Copper Connections
for a shower**
